**Flood Control Project Maintenance  
Levee Inspections**

## Maintenance Issue Types Only, Levee Inspection Report By Mile - Spring 2015

### Solano County Public Works Mellin Levee

Waterway	Bank	Unit Miles	Inspection Start/End	Inspector
Unit No. 01 Mellin Levee	Right	0.59	04/08/2015 04/08/2015	Richard Willoughby

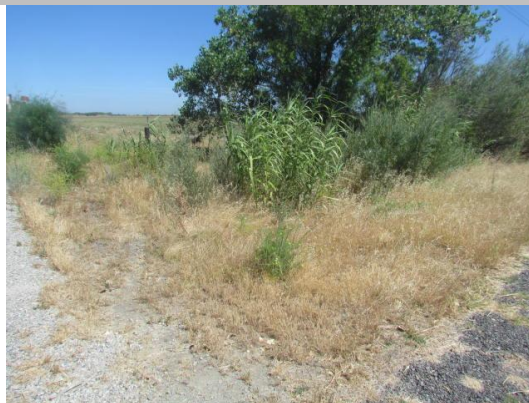
Photo 1 of 1 : SP\_2015\_NA0012\_258\_1\_20150309\_00001.jpg

LM Start	0.00	Rating **	M	Issue No.	1
LM End	0.00	Issue Type +	Ma	Location *	WS
Category	Earthen Levee			GPS Latitude/Longitude	
				Start	End
Item	Vegetation			38.174051 °	38.174051 °
				-121.674220 °	-121.674221 °
DWR ID	DWR_NA0012_01_s _ 2012_1				
Action/Comments					
Remove the wild growth other than native grasses from the levee slopes.					
Inspector Comments: Control Arundo on waterside slope at the entrance to the levee.

Looking west at arundo on waterside slope at entrance to unit.

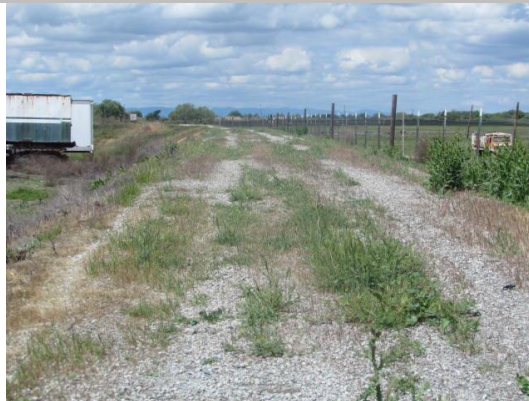
Photo 1 of 2 : SP\_2015\_NA0012\_258\_10\_20150409\_00006.jpg

LM Start	0.01	Rating **	M	Issue No.	10
LM End	0.59	Issue Type +	Ma	Location *	CR
Category	Earthen Levee			GPS Latitude/Longitude	
				Start	End
Item	Vegetation			38.175658 °	38.180044 °
				-121.676210 °	-121.681978 °
DWR ID	DWR_NA0012_01_s _ 2015_10				
Action/Comments					
Remove the wild growth other than native grasses from the levee slopes.					
Inspector Comments: Add appropriate gravel or road base.

Looking west at vegetation on levee crown at LM 0.00 to 0.10

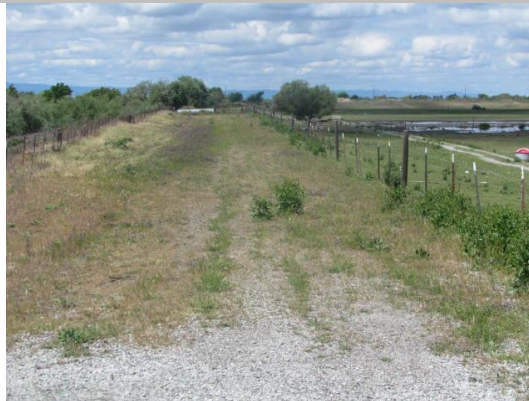
Photo 2 of 2 : SP\_2015\_NA0012\_258\_10\_20150409\_00007.jpg

Looking west at vegetation on levee crown at LM 0.28 to 0.59

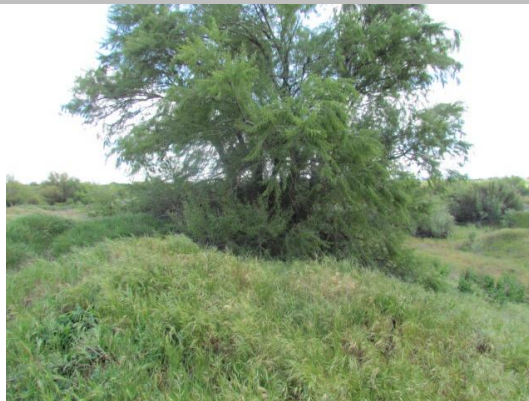
Photo 1 of 1 : SP\_2015\_NA0012\_258\_12\_20150409\_00008.jpg

Looking east at untrimmed tree on landward slope.

LM Start	0.58	Rating **	M	Issue No.	12
LM End	0.58	Issue Type +	Ma	Location *	LS
Category	Earthen Levee			GPS Latitude/Longitude	
				Start	End
Item	Trim / Thin Trees			38.179966 °	38.179966 °
				-121.681872 °	-121.681872 °
DWR ID	DWR_NA0012_01_s _ 2015_12				
Action/Comments					
Trim trees to at least five feet above ground level.
